# Mold Screen Inspection Report

**Advanced Home Inspection Services**

Inspection #: 115

Inspected Address: 1120 W. Dodger Ln.  
Santa Maria Ca 93458

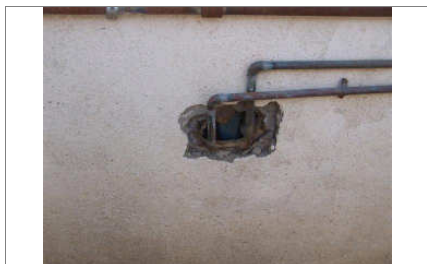
various openings around plumbing penetrations need repair/sealed

repairs needed to various damage and openings on exterior walls to prevent moisture intrusion

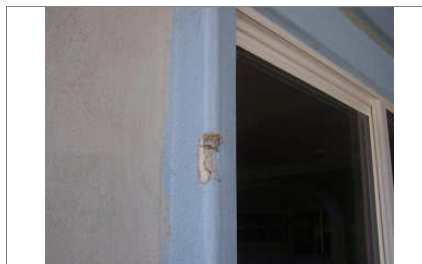
various areas with minor damage at stucco trim (EIFS)

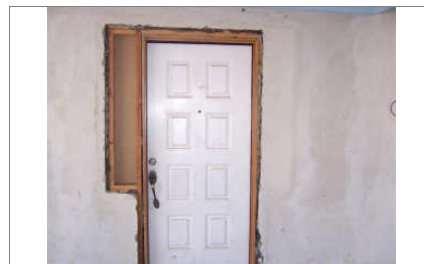
unfinished door install exposing interior to moisture intrusion

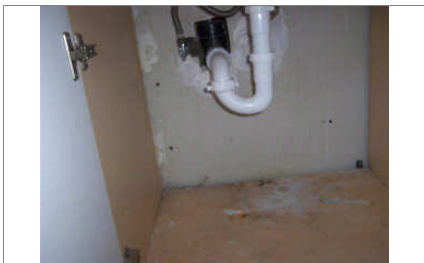
moisture stains under various bathroom sinks

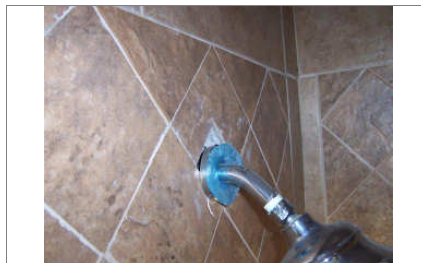
improper seal at showerhead. Recommend replacement of ring to prevent moisture intrusion in wall

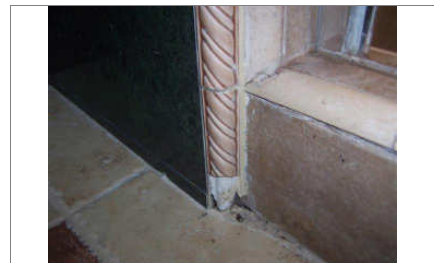
missing trim tile at shower stem wall. Recommend patching for water tightness

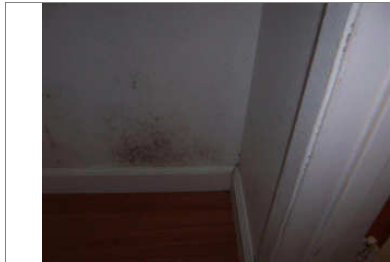
possible mold noted in downstairs bedroom walls

mold like substance noted in bedroom closet

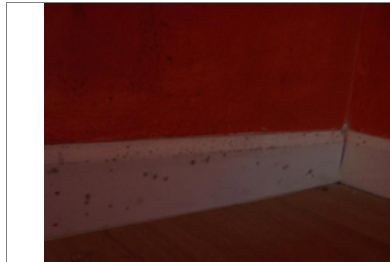
mold like substance at baseboard and at wall nearby

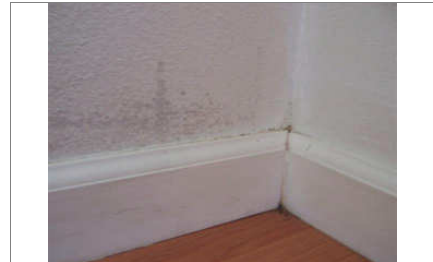
possible mold like substance appears to have been previously painted over

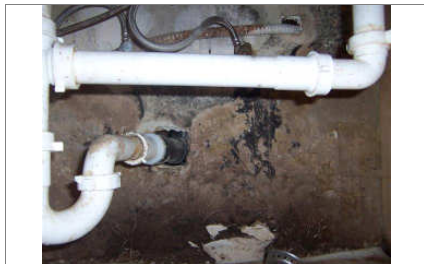
excessive mold like substance noted below kitchen sink with active leak noted at drain line

excessive mold like substance below sink.....

Moisture intrusion from second floor patio noted entering into rear patio and kitchen exterior wall. Excessive mold like substance with active moisture noted at base of wall in kitchen inside lower cabinets. Recommend sampling and/or professional remediation.

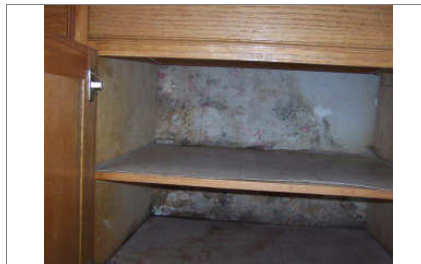
as well as adjoining cabinet

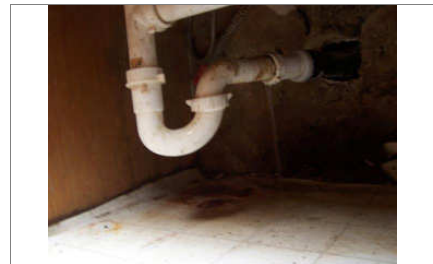
active leak at drain

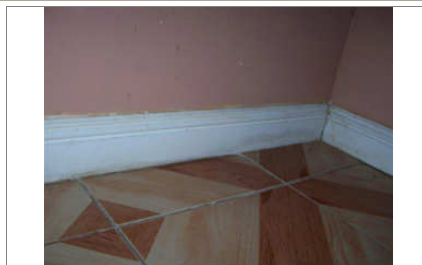
moisture stains noted

Moisture stains noted at various areas. Recommend monitoring areas.

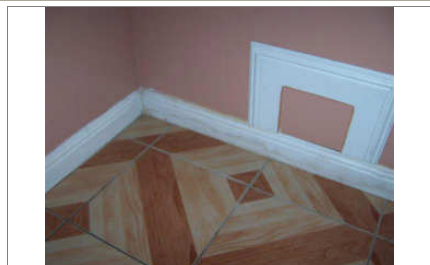
possible previous leak

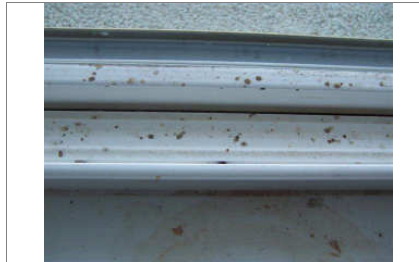
showing signs of minor mold spore buildup
