Mold Screen Inspection Report

Advanced Home Inspection Services

Inspection Date & Time: 4/10/2009 4:00 PM

Inspected Address: 1120 W. Dodger Ln.
Las Vegas Nv 89123

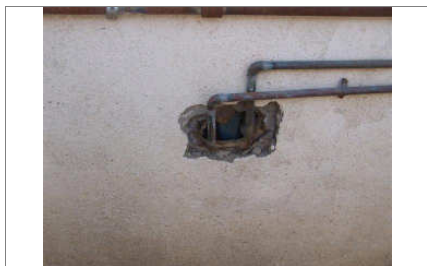
various openings around plumbing penetrations need repair/sealed

repairs needed to various damage and openings on exterior walls to prevent moisture intrusion

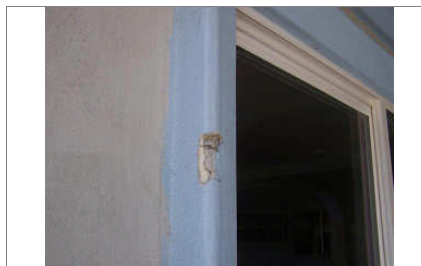
various areas with minor damage at stucco trim (EIFS)

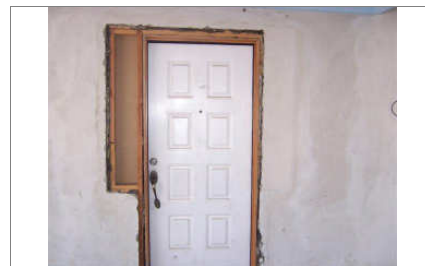
unfinished door install exposing interior to moisture intrusion

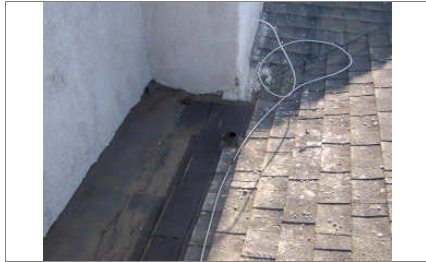
improper step flashing at roof to deck

maintenance and repairs needed to prevent moisture intrusion

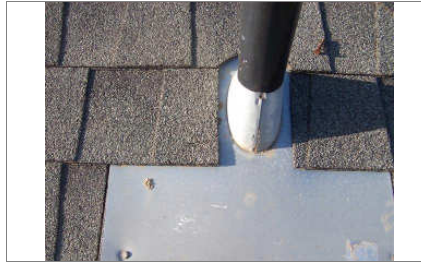
typical maintenance and seal needed at roof jack sleeves

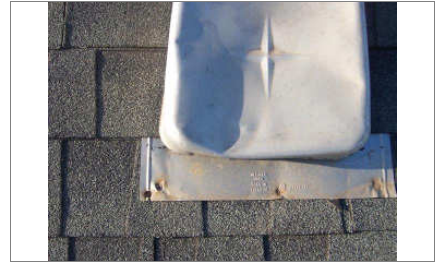
various flashing with exposed fasteners. Maintenance recommended

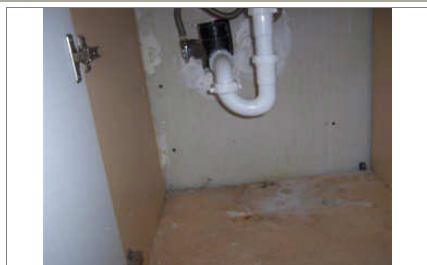
moisture stains under various bathroom sinks

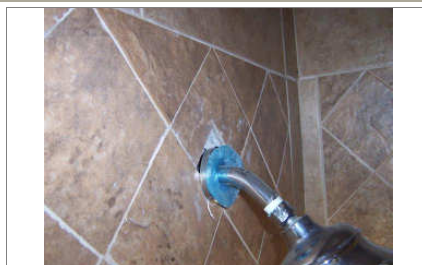
improper seal at showerhead. Recommend replacement of ring to prevent moisture intrusion in wall

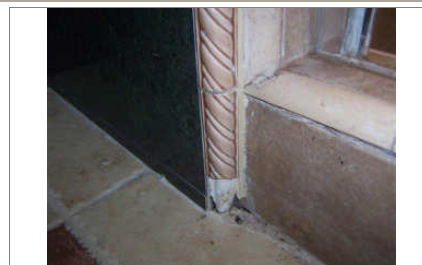
missing trim tile at shower stem wall. Recommend patching for water tightness

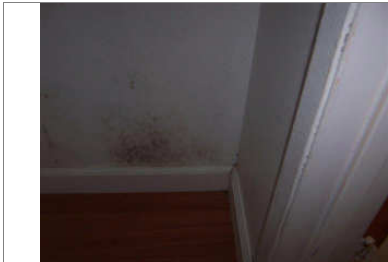
possible mold noted in downstairs bedroom walls

mold like substance noted in bedroom closet

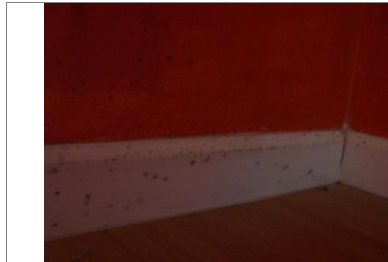
mold like substance at baseboard and at wall nearby

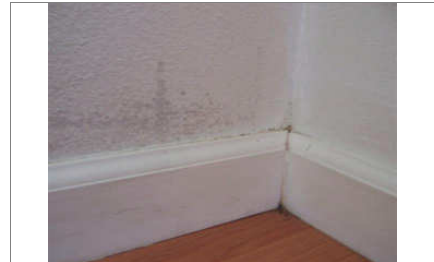
possible mold like substance appears to have been previously painted over

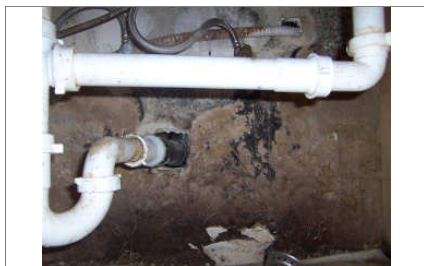
excessive mold like substance noted below kitchen sink with active leak noted at drain line

excessive mold like substance below sink.....

Moisture intrusion from second floor patio noted entering into rear patio and kitchen exterior wall. Excessive mold like substance with active moisture noted at base of wall in kitchen inside lower cabinets. Recommend sampling and/or professional remediation.

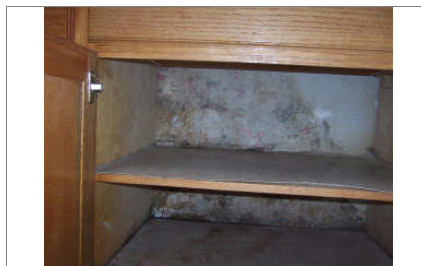
as well as adjoining cabinet

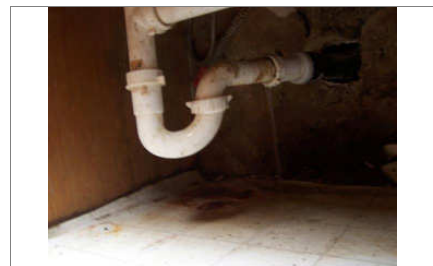
active leak at drain

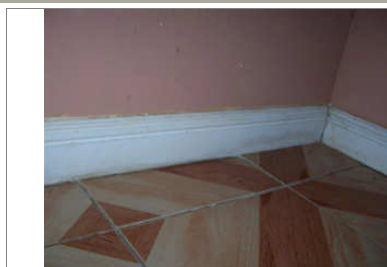
moisture stains noted

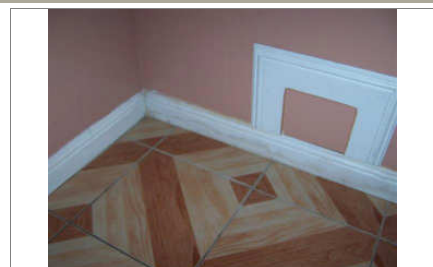
possible previous leak

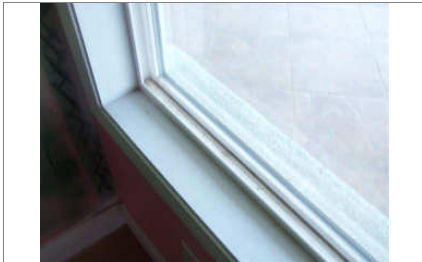
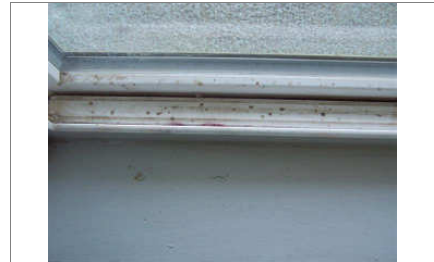
various window

showing signs of minor mold spore buildup
